Manhole Inspection Summary

Manhole # S39EE_033MH

Insp Date: **1/14/08 1:56 PM**

Location Address: **1100 AISQUITH**

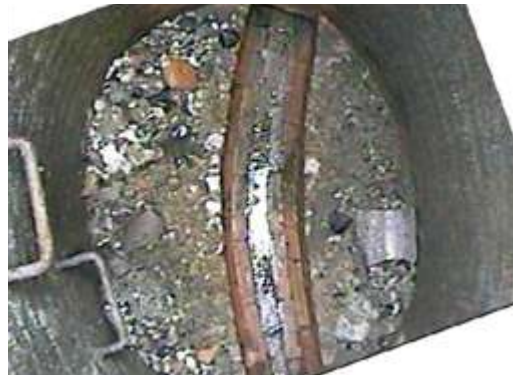
Defect 1

Condition: ☐ Sound ☐ Cracked ☐ Root Intrusion ☐ Deteriorated ☐ Leaks ☒ **Debris**

Steps Count: **3** Missing: **0** ☒ **Corroded**

Surcharge ☒ **Evidence Of Surcharge** Depth: **1** (ft.) ☐ Active Surcharge Present

debris; evidence surcharge; corroded step

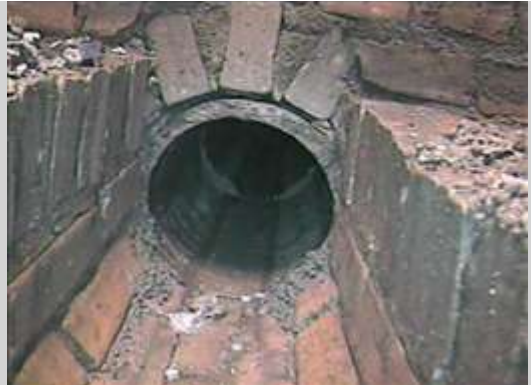
12 O'Clock Outflow

8 in. Circular Gravity Sewer
Pipe Out @ 12 O'Clock

Infiltration: **None** Pipe Seal Cond: **Sound**

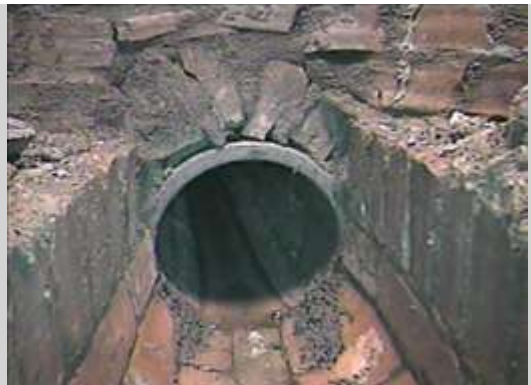
5 O'Clock Inflow

8 in. Circular Gravity Sewer
Pipe In @ 5 O'Clock

Infiltration: **None** Pipe Seal Cond: **Sound**
